The
“Goldfinders Inn Group”

Kurrajong, New South Wales

CONSERVATION HISTORY – VOLUME 2

JULY 2022

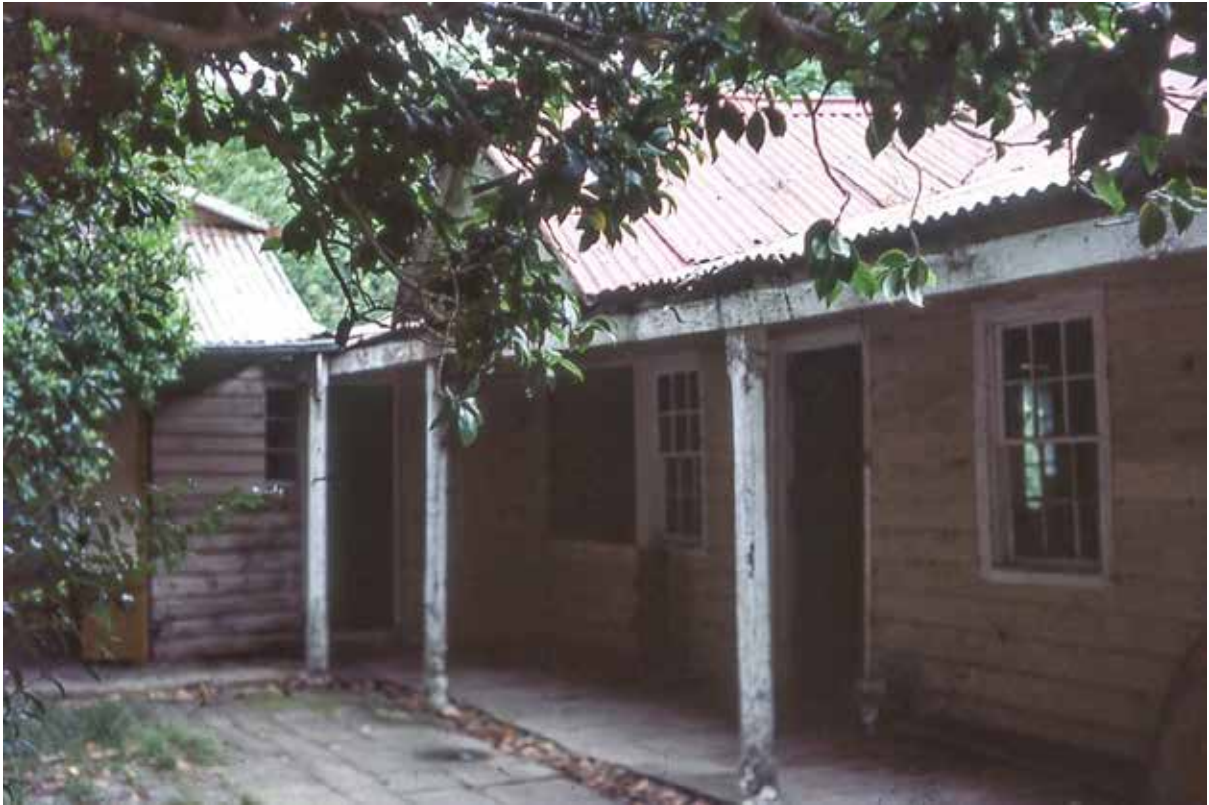
Figure 29 – Front - 1975

Looking at the West Elevation shown on Figure 25, there was a gable above the front door. This gable, also shown in Figures 29 and 30, was removed. Note that Figure 25 also shows matching front windows on the façade to the left (north) of the front door. As discussed above, as shown in Figure 29, one window was a large plate glass window, subsequently replaced by the matching 12-pane window shown in Figure 25. Figure 25 also shows a verandah roof around Room F, with this roof also seen in the South Elevation shown in Figure 26. This verandah roof was removed and a small portico-style roof installed above Door 4. Door 4 remains, but with the infill panels removed. Windows (5) on the western side of Room F remain unaltered. The works undertaken in 1987 did not allow under-floor ventilation of Room F, resulting in rot in some floor joists. In 2021 these were repaired/replaced and a path of ventilation opened up. In addition, the verandah roof on the western side was replaced and a portico-roof added to the northern side, matching the portico-roof on the southern side.

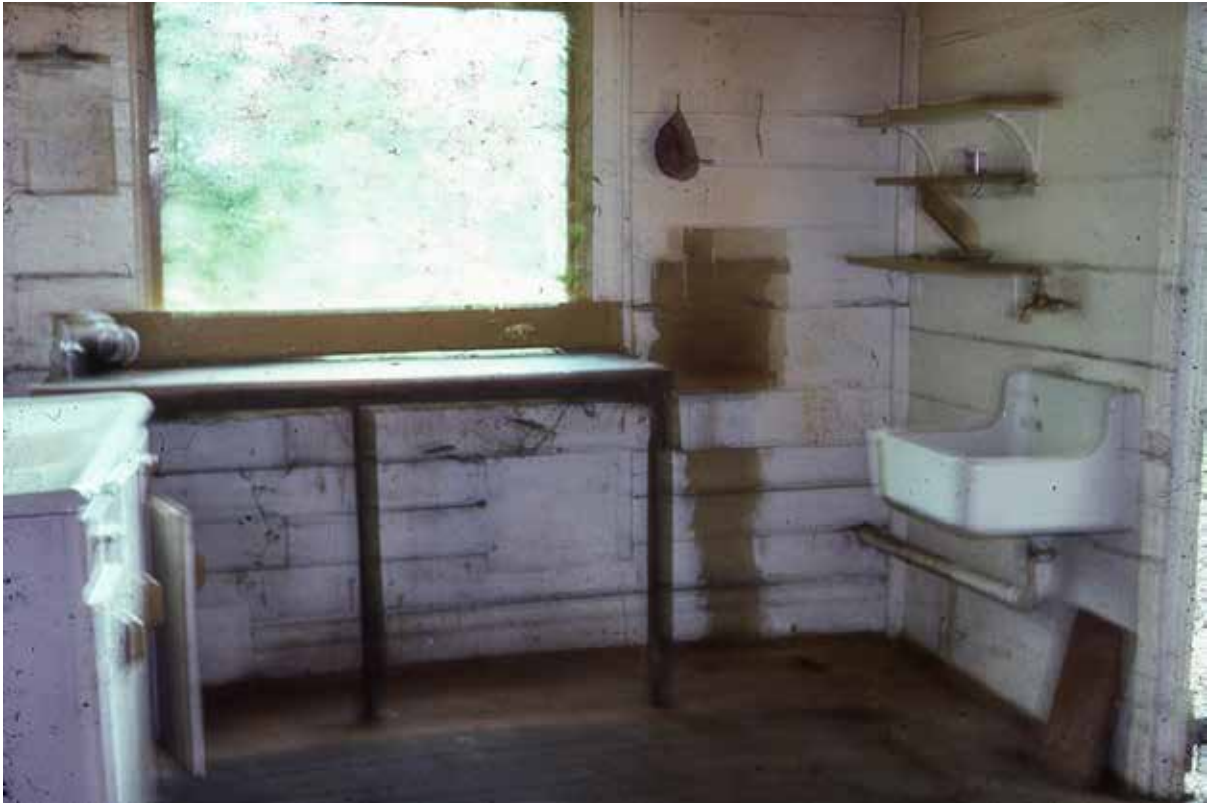
Figure 40 – Inside original kitchen - 13 - 1975

Figure 40 shows a view of the kitchen in 1975, with plate glass window, sink on right and stand for a tabletop stove on the left, providing a very basic kitchen. Figure 41 shows the “upgrading” kitchen works, with a stainless-steel bench and relocated sink. Figure 43 provides another view of the kitchen. Figure 42 is a photograph that looks along Room G towards the kitchen and the fireplace. This shows the refurbishment works undertaken in

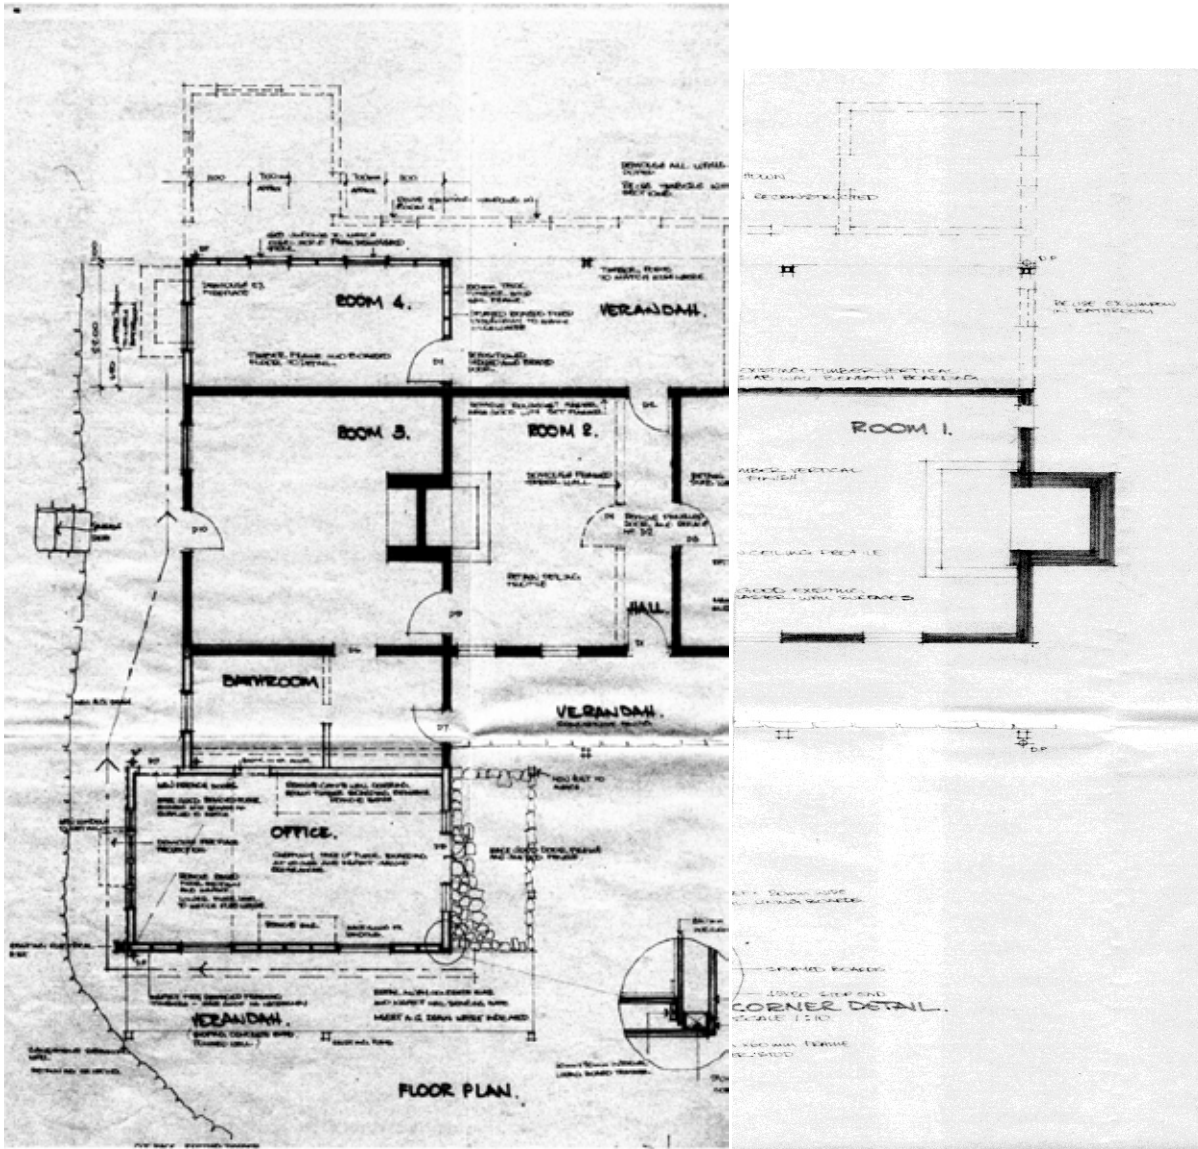
Figure 52 – Conservation Work Plan

As indicated in the plan in Figure 52 above, the key decision in the conservation work was to demolish the later additions on the eastern side, reducing the main building to a depth of one room. From a practical point of view, the plan took into account the work that had already been undertaken in the conservation and rebuilding of the inn, with this work including the construction of a new kitchen. Thus there was no longer a need to maintain a kitchen in the cottage, and in fact in local government building regulation terms, it would not have been legal to have a kitchen in the cottage as well as in the inn because this would have resulted in two free-standing dwellings on the property. In theory, Room 4 in the plan above could have been a kitchen, but one requiring meals to be carried into Room 2. The major work in Room 2 was the removal of the internal wall on the northern side of the corridor, a wall that was clearly a later addition.

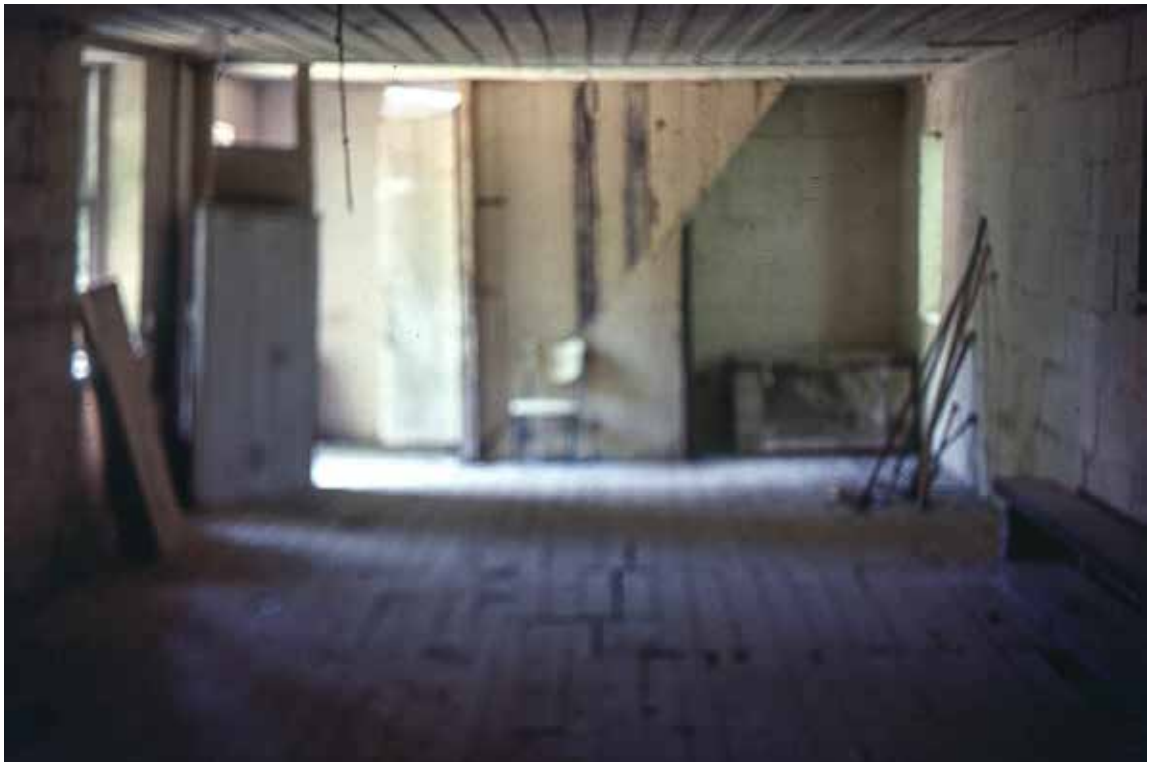
Figure 64 Inside ground floor, looking to stairs - 1975

Figure 64 shows the inside ground floor in 1975, looking from the front towards the stairs. (There is another photograph in Figure 29 of the 2014 Report.¹) These photographs show a relatively rough floor, with six inch wide butt-jointed boards. The stone walls are painted. The ceiling consists of butt-jointed flat boards, with thin timber strips overlaid on the joints. Figure 64 shows the 45-degree angle of the original staircase. With the angle and width of this original staircase, in the 1979 works it was replaced with a staircase wider and not as steep. The original staircase treads were relocated for the new stairway into the attic.

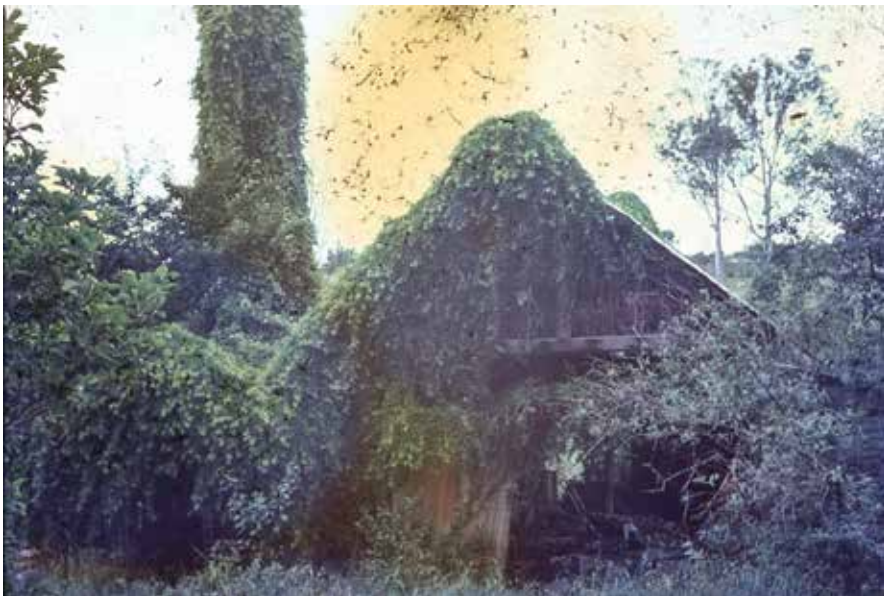
Figure 69 – Barn 1975

Figures 19, 20, 22 and 23 literally provide an overview of the outbuildings. Figure 69 shows the northern face of the barn as found in 1975, complete with overgrowth and an old telegraph pole behind. By 1977 (Figure 70) some clearing had been undertaken, but not much. Figure 71 provides a good view of the western side, facing the cottage, with some timber doors remaining. Even by 1983 (Figure 72) the barn was still characterised by heavy overgrowth, although at least the inside was clear enough to be used as a garage.

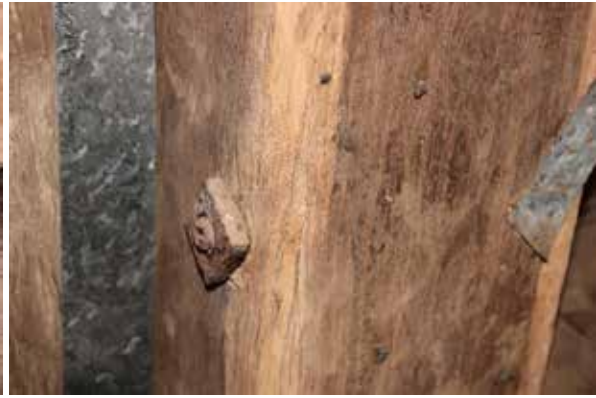
Figure 78 Screw on other end of hinge bar

Figures 77 and 78 show a gudgeon post hinge for large barn doors. In Figure 77 the post is missing. It was contained by a wrap of the metal bar. Figure 78 shows the other end of the hinge bar, with a screw thread and nut fixing the bar. Structural support has been provided by tin strips, while additional tin strips have been nailed over the joints in the vertical timber slabs, to improve the weather protection, a technique traditionally used.

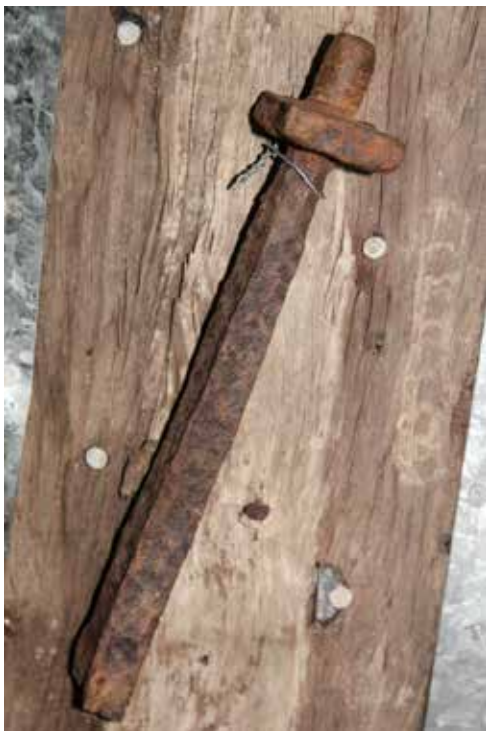
Figure 79 Bolt with broken head

Figure 79 shows an example of one of the bolts used in constructing this barn, with a square section iron bar, with a screw thread turned on one end. The bolt head is missing. Figure 80 shows another door post hinge. What is interesting is that this is a different type of construction to that shown in Figure 77, with a round section bar hammered into the post of the barn, without a screw at the other end.

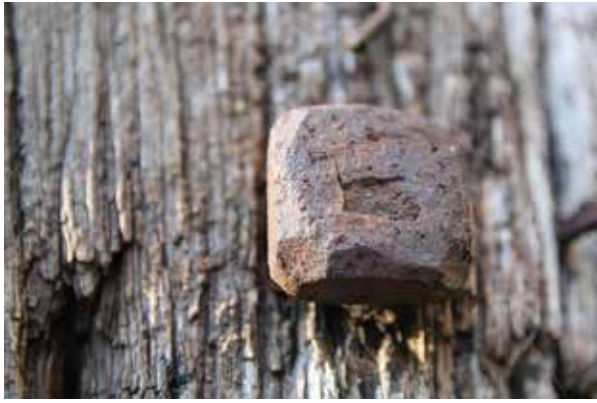
Figure 81 Head of bolt

Figure 81 shows the head of a bolt on the outside of the barn, forged onto a square section bar. Figure 82 shows another bolt in situ, but with the screw thread on the end broken, and nut missing.
