The
“Goldfinders Inn Group”

Kurrajong, New South Wales

CONSERVATION HISTORY – VOLUME 2

JULY 2022

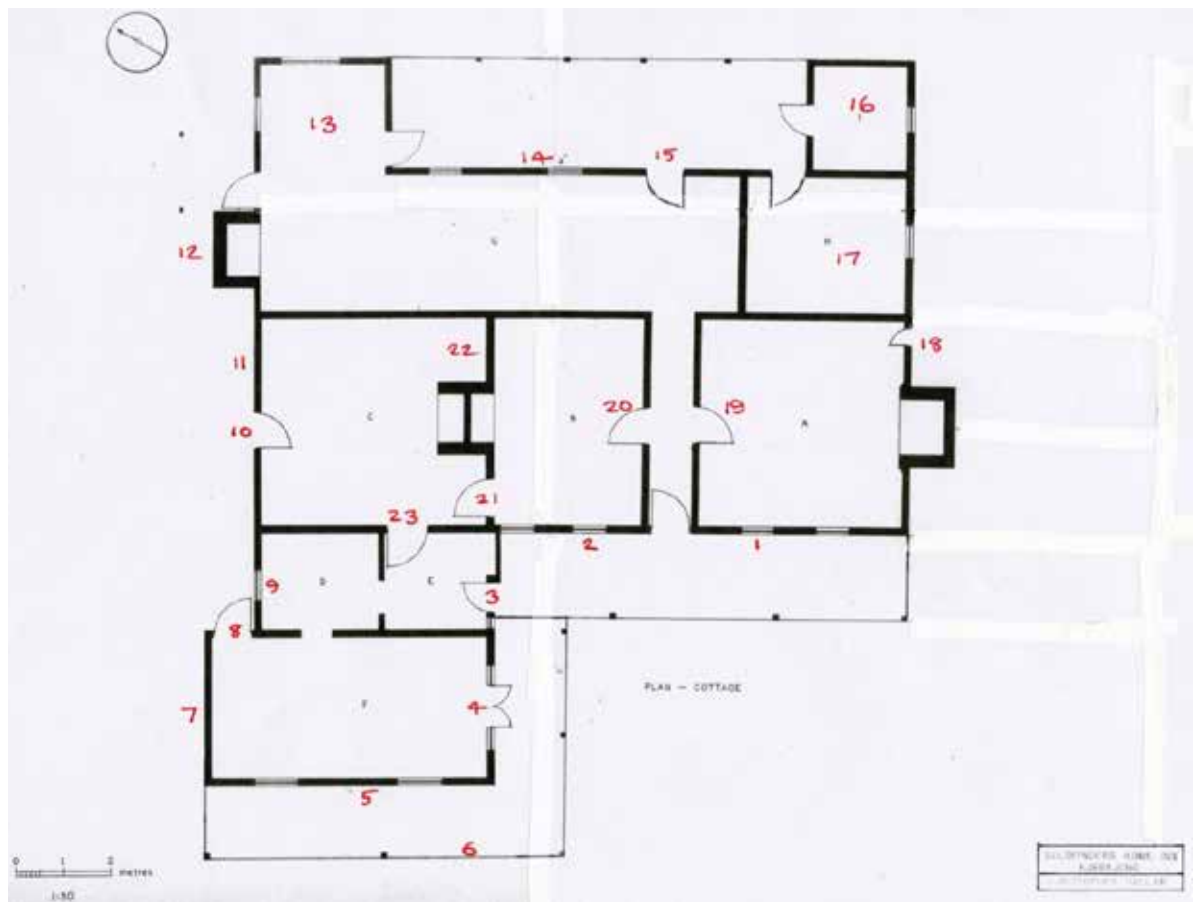
Figure 24 – Cottage Floor Plan in 1977

Looking back to Figure 24, the 1977 floor plan of the cottage, the changes made can be reviewed through the numbers on this plan. The front windows (1) were not changed. The front door, not labelled but shown on the inside in Figure 46, remains unaltered, with internal paint removed and a replacement Carpenter lock of the correct period and size fitted. The front door knob remains as existing in 1975. The second set of front windows (2) have been altered. In 1975, as shown in Figure 29, the more northern window was a plate glass window, installed during the Adolphus period of ownership, to let more light into what is shown on Figure 24 as Room B. This was removed and a replacement window to match the other windows on this façade installed. This replacement window was from demolished works (14).

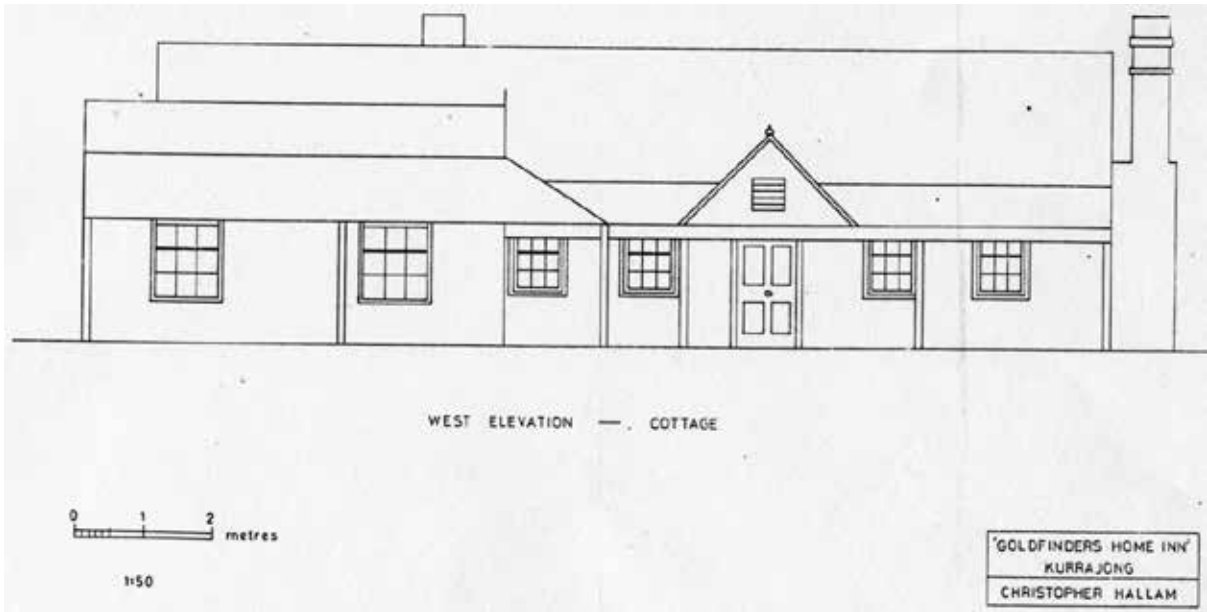
Figure 25 – West Elevation

Looking at the West Elevation shown on Figure 25, there was a gable above the front door. This gable, also shown in Figures 29 and 30, was removed. Note that Figure 25 also shows matching front windows on the façade to the left (north) of the front door. As discussed above, as shown in Figure 29, one window was a large plate glass window, subsequently replaced by the matching 12-pane window shown in Figure 25. Figure 25 also shows a verandah roof around Room F, with this roof also seen in the South Elevation shown in Figure 26. This verandah roof was removed and a small portico-style roof installed above Door 4. Door 4 remains, but with the infill panels removed. Windows (5) on the western side of Room F remain unaltered. The works undertaken in 1987 did not allow under-floor ventilation of Room F, resulting in rot in some floor joists. In 2021 these were repaired/replaced and a path of ventilation opened up. In addition, the verandah roof on the western side was replaced and a portico-roof added to the northern side, matching the portico-roof on the southern side.

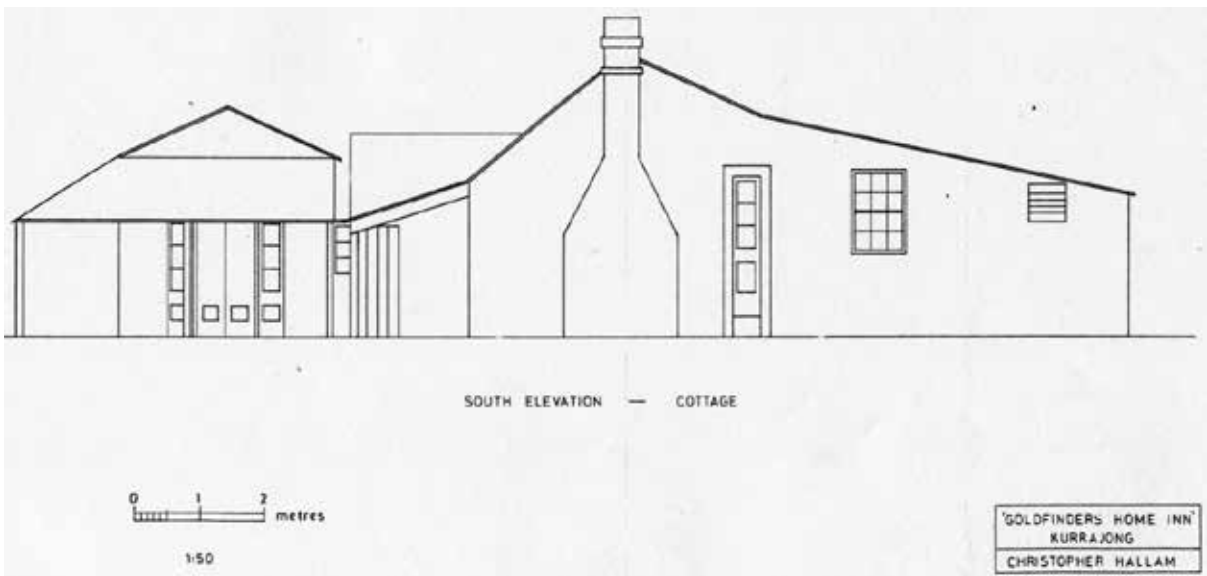
Figure 26 – South Elevation

The South elevation shown in Figure 26 shows the slatted glass bathroom window (Room 16), the window in Room 17 and the narrow door (18) to Room A. This door (18) is seen in the photograph in Figure 32. While of similar style to the doors (4) to Room F, with Room A appearing to be the earliest room in the cottage, this door (18) was clearly a later addition and one inconsistent with the layout of Room A. It can be seen from the inside of Room A in Figure 39.

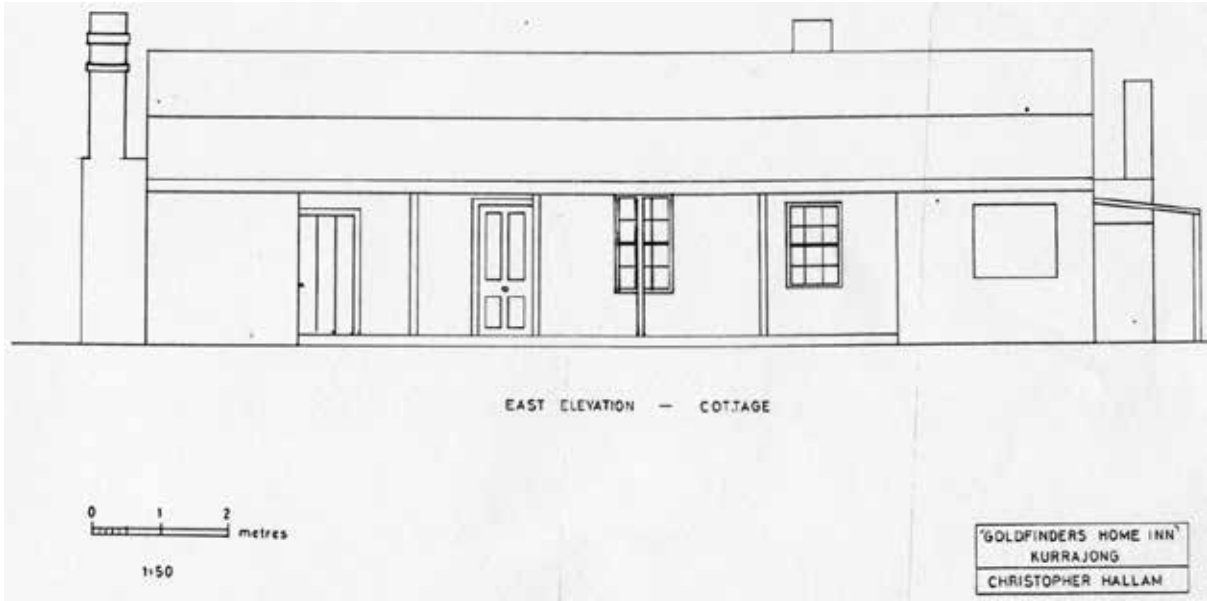
Figure 27 – East Elevation

The East elevation as shown in Figure 27 has been totally altered, with the removal of the eastern extension of the cottage. The kitchen (Room 13) had a plate glass window. The windows (14) were re-used in the works. Doorway (15) was a later Victorian door that was not re-used. It can be seen in the 1984 photograph shown in Figure 34. Room 16 was the bathroom, with Figure 35 showing the view along the verandah to this room. The toilet was an external pan-collect type, located near the barn. The interior of this bathroom is shown in Figure 49. The adjacent Room 17 (H) was demolished, but its ledge and brace door was re-used. The photograph shown in Figure 36 shows the rear yard in 1975, complete with grape vines and an old inn lantern. Figure 33 shows the East elevation in 1975/76 after some clearing of vegetation was undertaken. This shows a circular iron water tank on the left, outside the bathroom, Room (16). This water tank can also be seen in Figure 35. Figure 34 shows the elevation in 1984, after the restoration works on the inn were completed but before the works on the cottage were commenced.

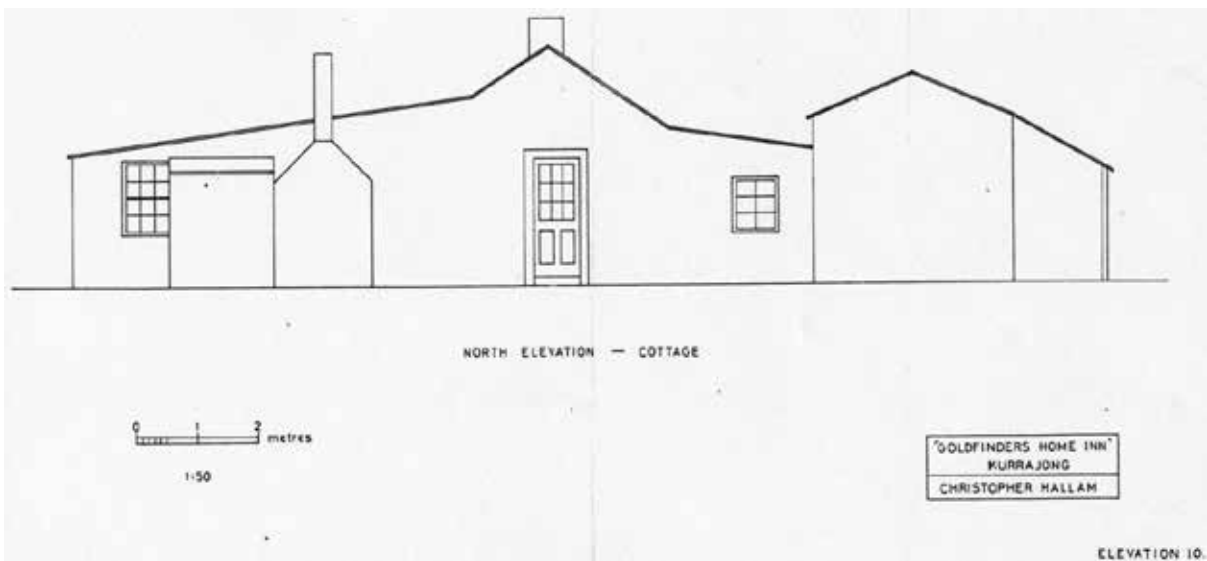
Figure 28 – North Elevation

Looking at the North façade shown in Figure 28, the central cottage section shows a window (9) and a door (10). The 1940 view in Figure 38 shows window (9) but indicates that Door (10) was previously a window. The Figure 24 floorplan shows another window in Room C, labelled (11). This window was added during the 1987 conservation works. A window removed from one of the demolished sections was utilised.

Figure 24 shows the later extended kitchen section, with details also shown in the Figure 28 North elevation. There is a fireplace, a doorway and a window. Some of this is shown in the 1940 photograph (Figure 38) and in the 1975 photograph (Figure 37). These later additions were demolished in 1987. Note that this kitchen area (Room 13) previously extended further to the East, as indicated by stone footings in the ground and as suggested in the mural painted in the 1940s, reproduced as Figure 19 in the 2014 Report.

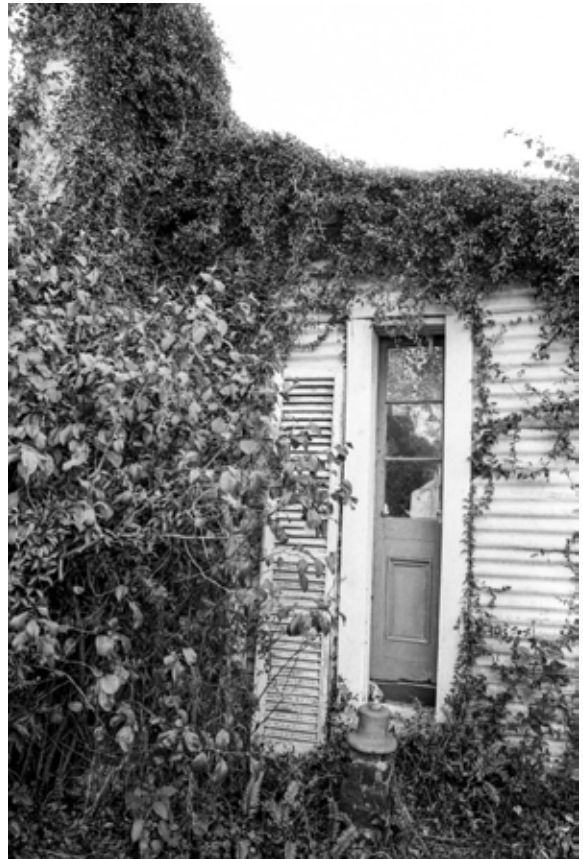
Figure 32 – Early Door 18 to Room A

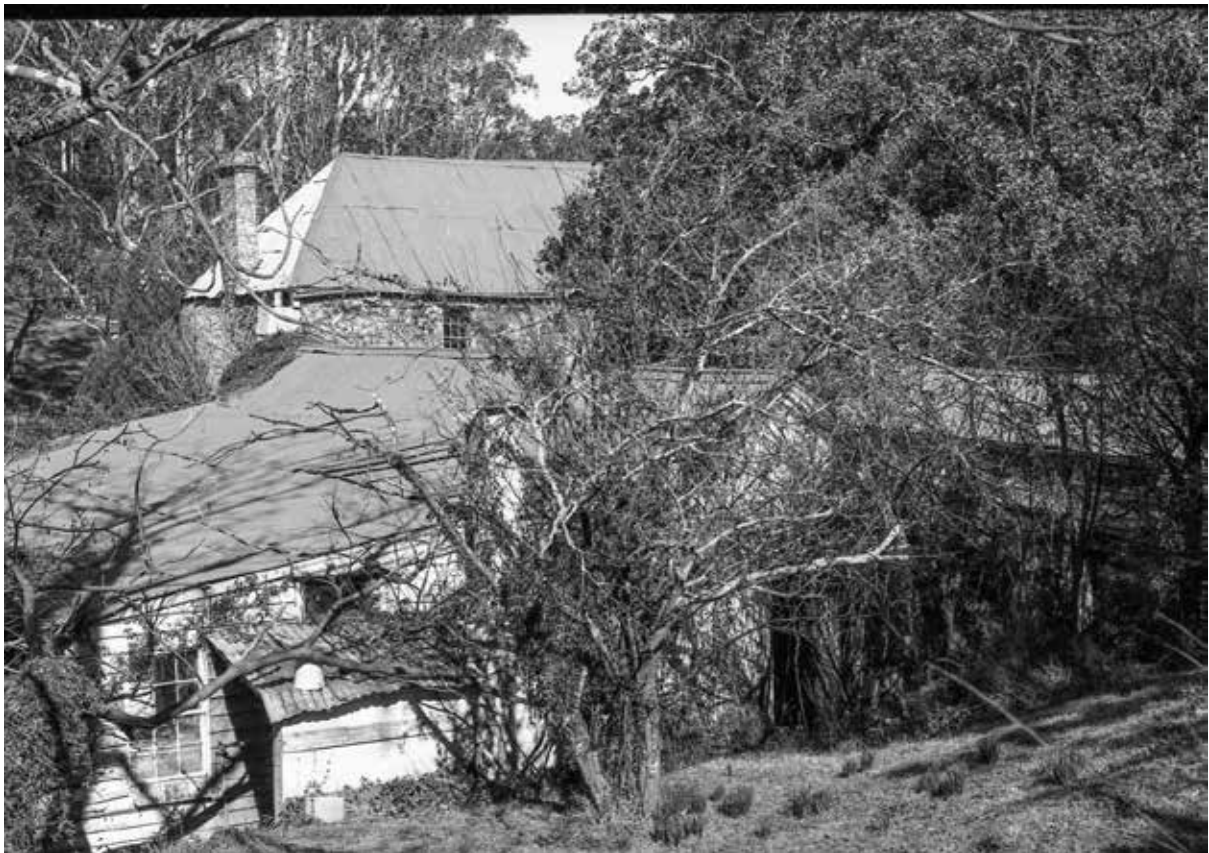
Figure 37 – Looking down from the North – 1975/76

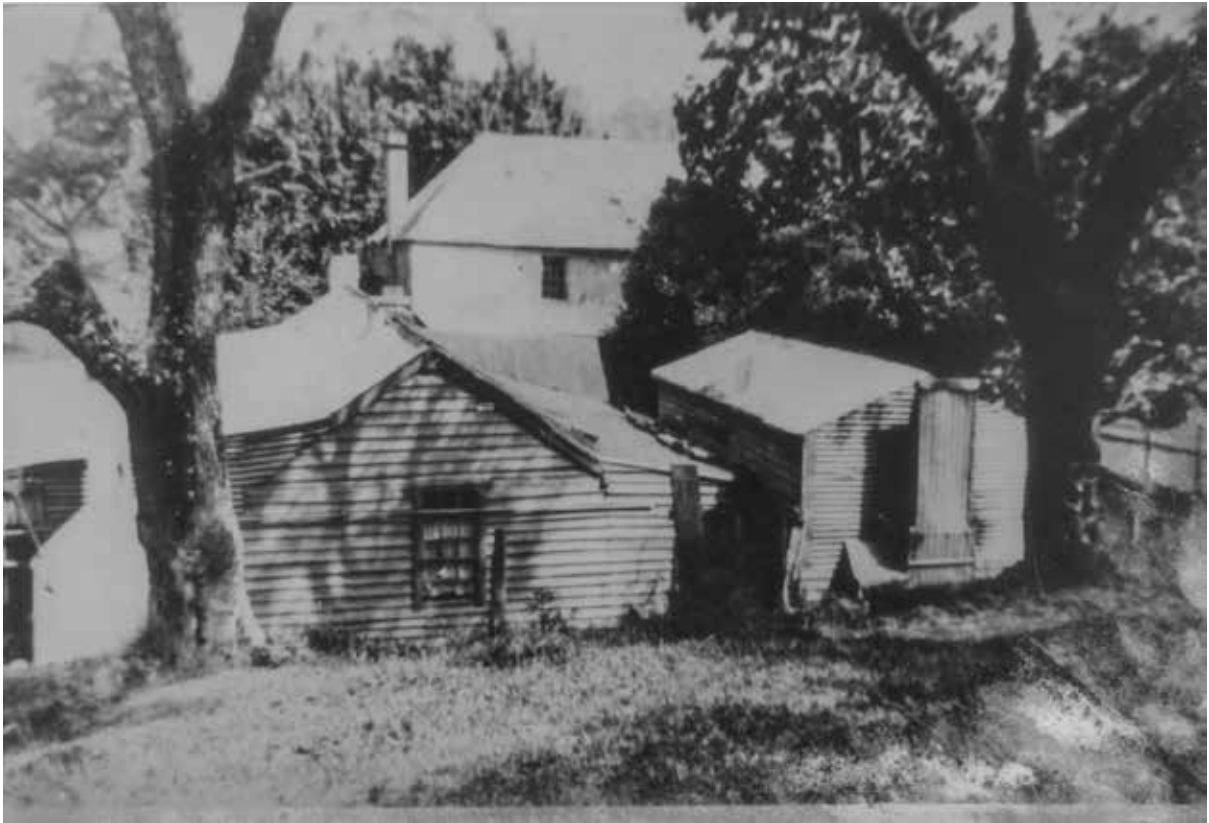
Figure 38 – Looking down from North – c1940

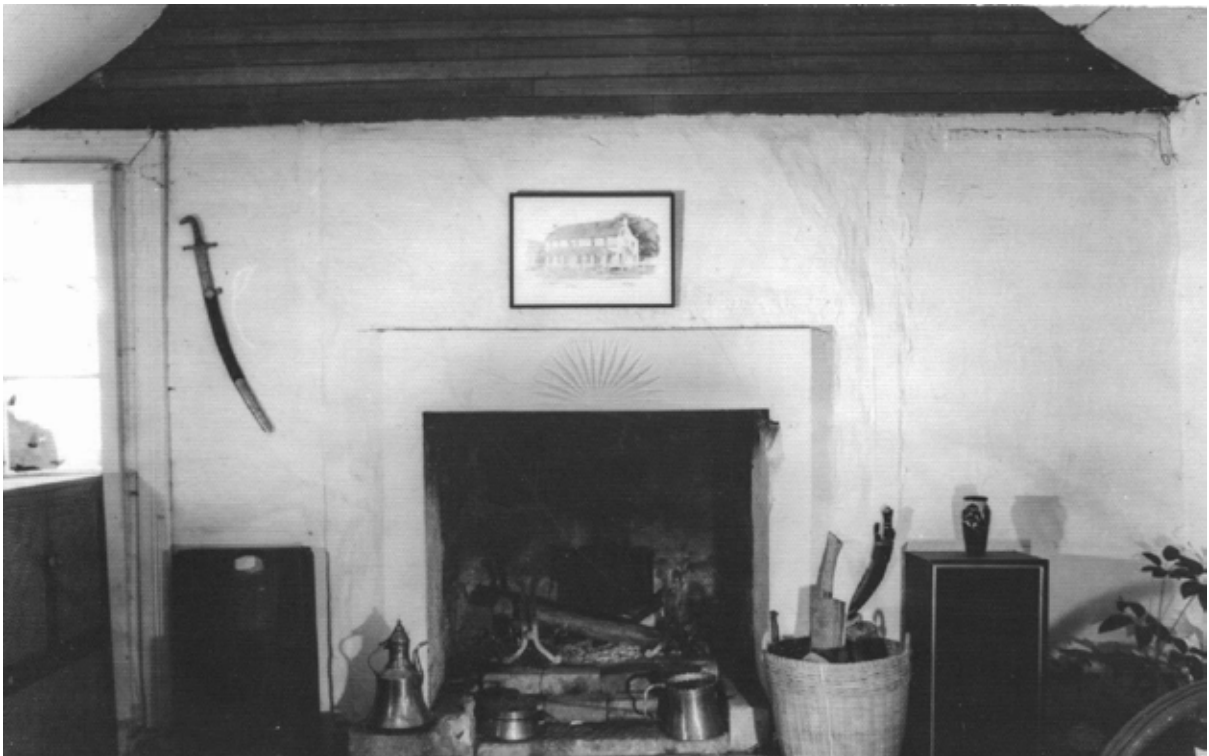
Figure 39 – Inside Room A - 1977

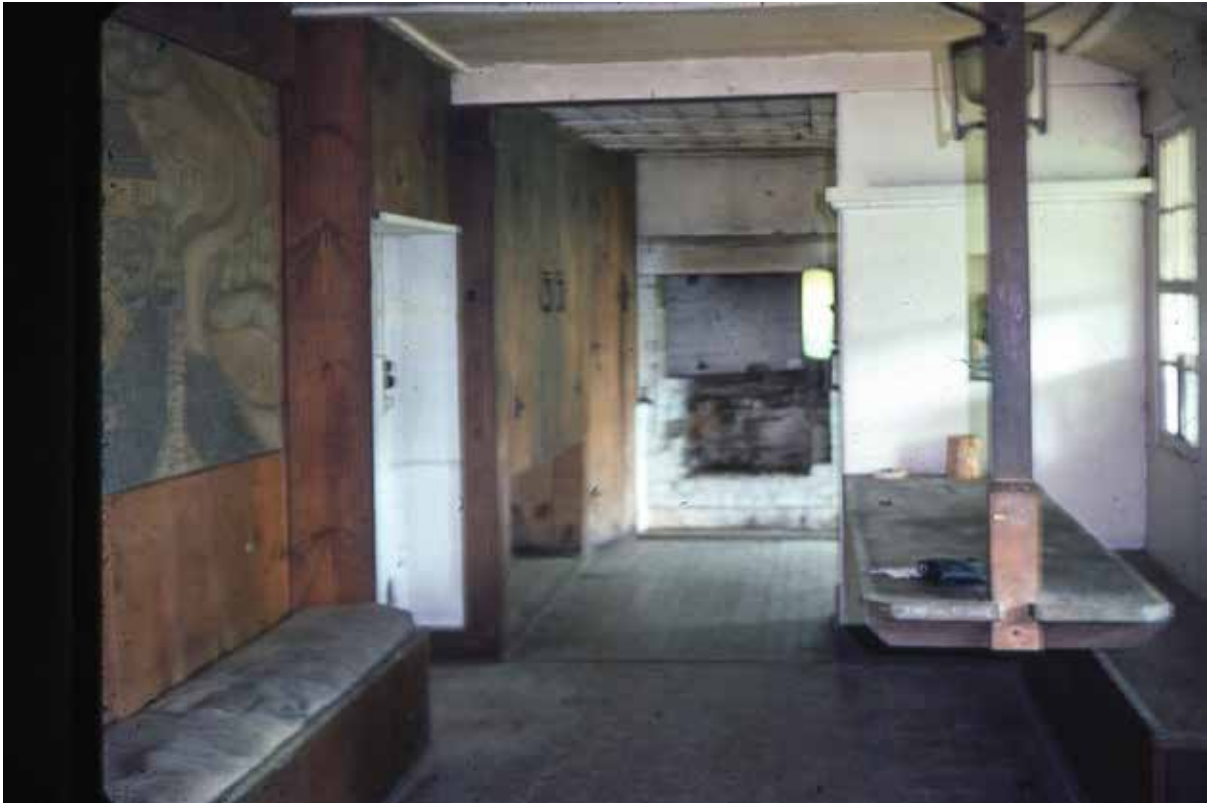
Figure 42 – Dining Room G, with mural on left and hanging table on right

Figure 40 shows a view of the kitchen in 1975, with plate glass window, sink on right and stand for a tabletop stove on the left, providing a very basic kitchen. Figure 41 shows the “upgrading” kitchen works, with a stainless-steel bench and relocated sink. Figure 43 provides another view of the kitchen. Figure 42 is a photograph that looks along Room G towards the kitchen and the fireplace. This shows the refurbishment works undertaken in

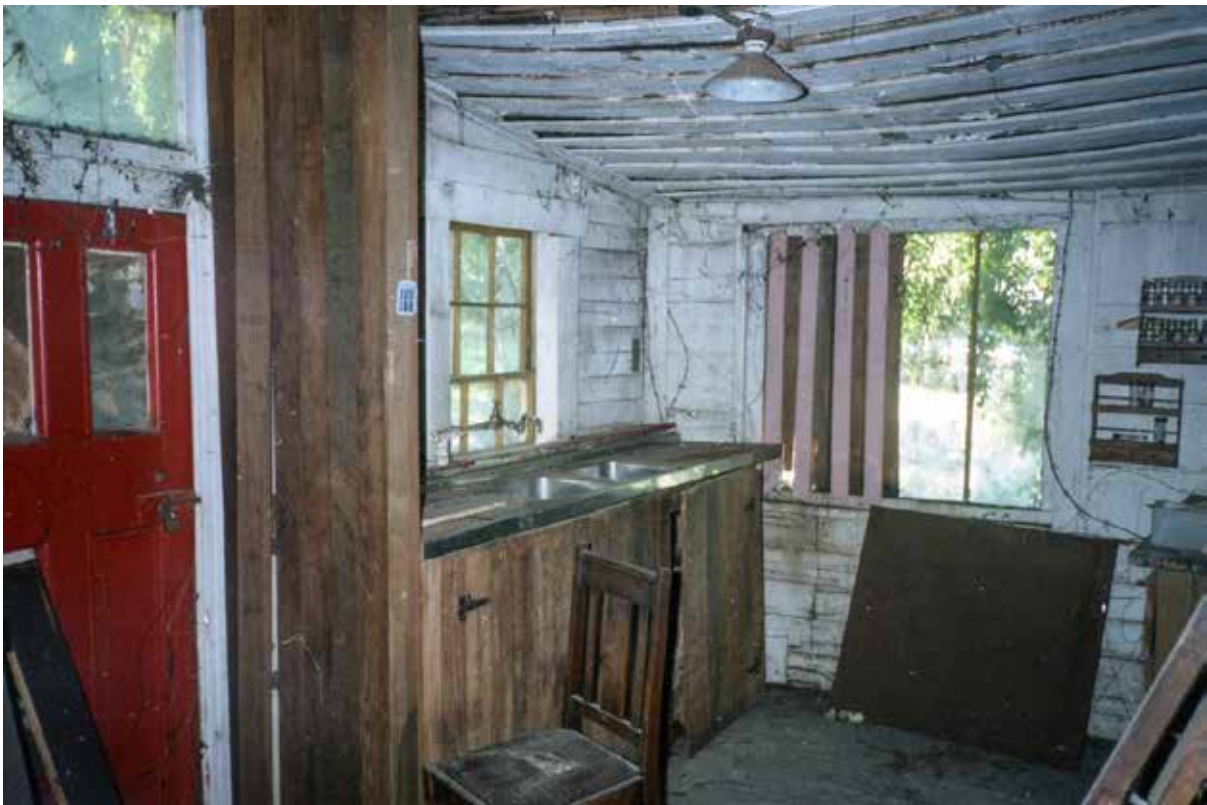
Figure 43 – Another view of original kitchen, including new bench and sink

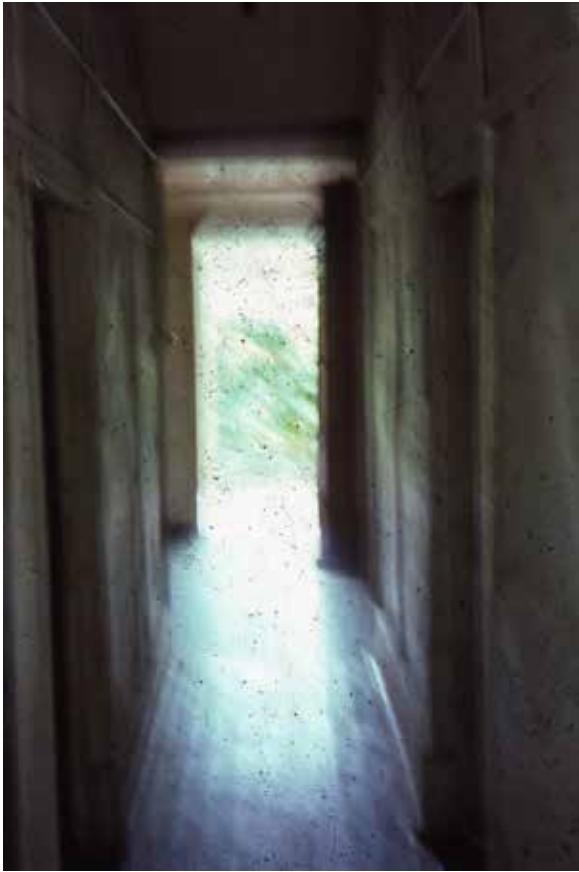
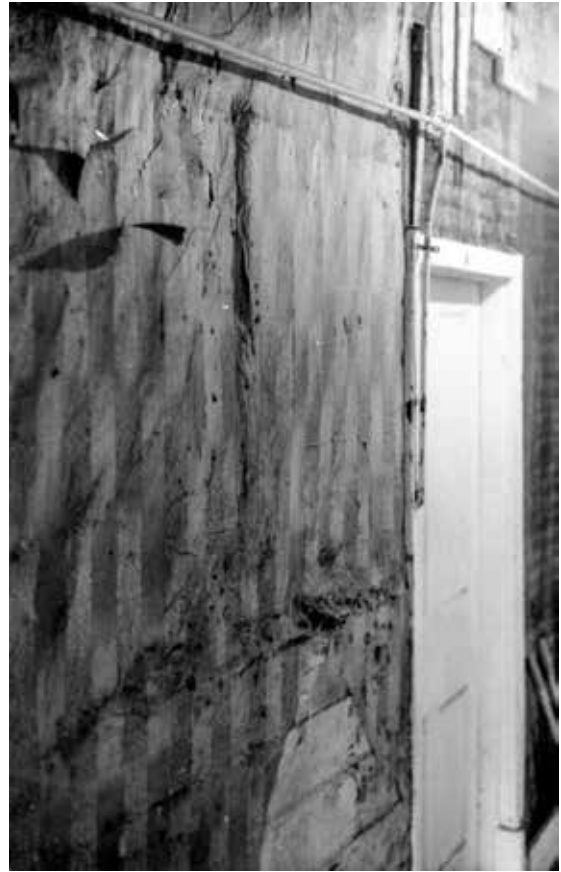
Figure 44 – Hallway looking to rear

The original hallway through the centre of the cottage can be seen in Figures 44 and 45. Both side walls were covered in tin sheet. The wall to Room B, on the left in Figure 44, had a simple timber frame inside the cladding. The wall to Room A shown on the right, and also in Figure 45, had the tin sheets nailed over the original slab wall. Both doors 19 and 20 have been retained, with door 20 relocated to door 3, providing a matching pair of cedar panelled doors.

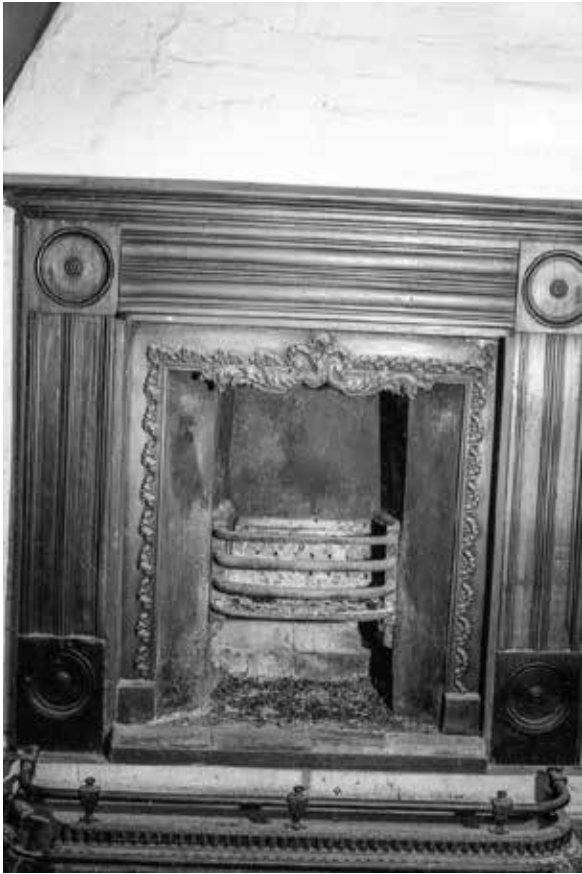
Figure 48 – Fireplace in Room C

As evident from the photographs shown in the 2014 Report,¹ Room C was a later addition to Rooms A and B, with the fireplace in Room C originally the outer face of the Room B chimney. In 1975 the Room C fireplace was as seen in Figure 48. There has been a suggestion that a previous owner, probably Terry Paul, installed this ornate fireplace and chimney piece, taken from an early Windsor building. The chimney piece has been relocated in the fireplace inside the inn. The iron fireplace has not been used. Room C had an earlier doorway (Door 22), shown in Figure 49. This has now been covered. It appears likely that door 22 was in place before door 21. A simpler chimney piece has been installed in this room.

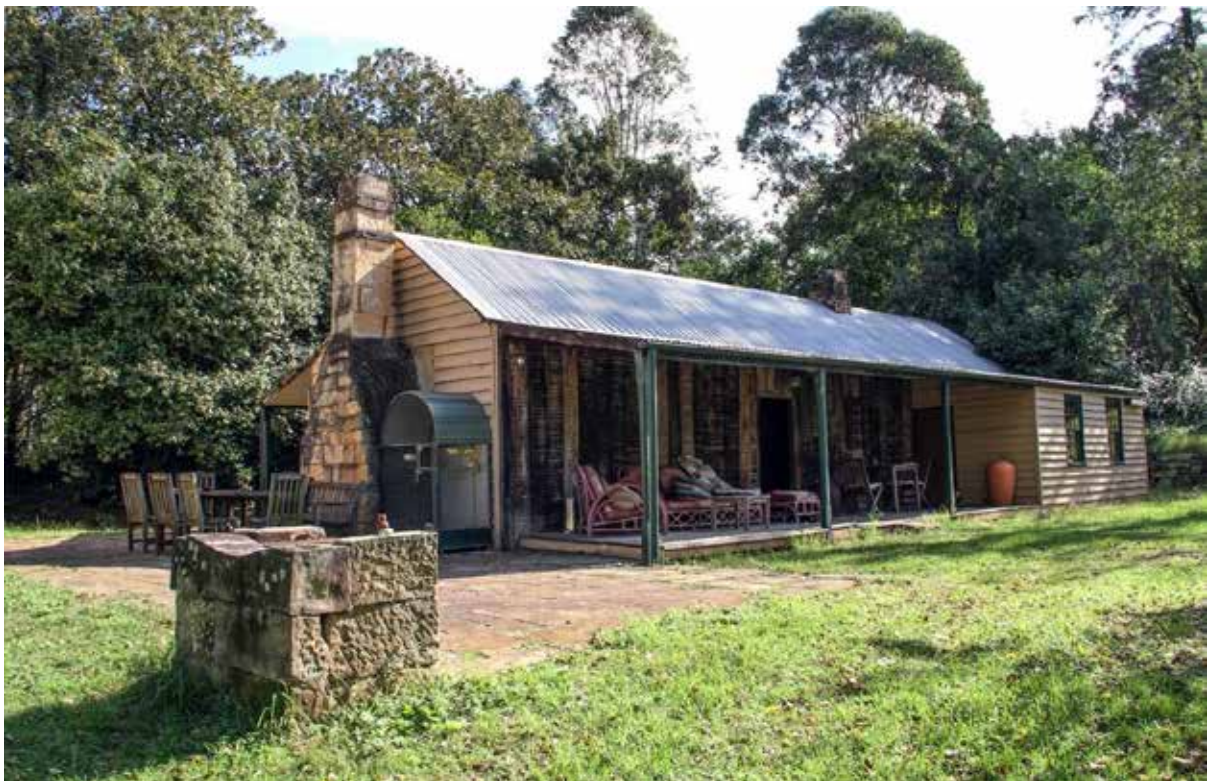
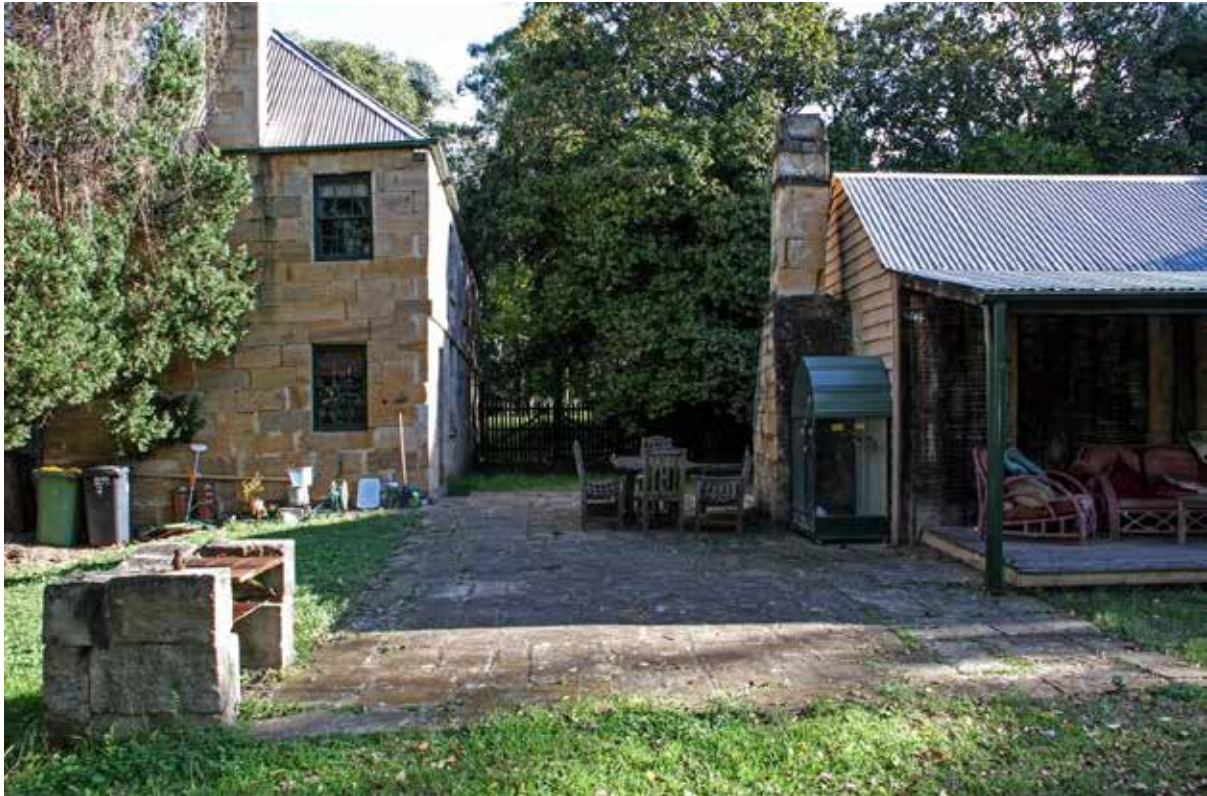
Figure 50 – Rear of cottage in early 2010, prior to connection to inn

Figures 50 and 51 show the rear of the cottage in early 2010, before the connecting room was constructed.

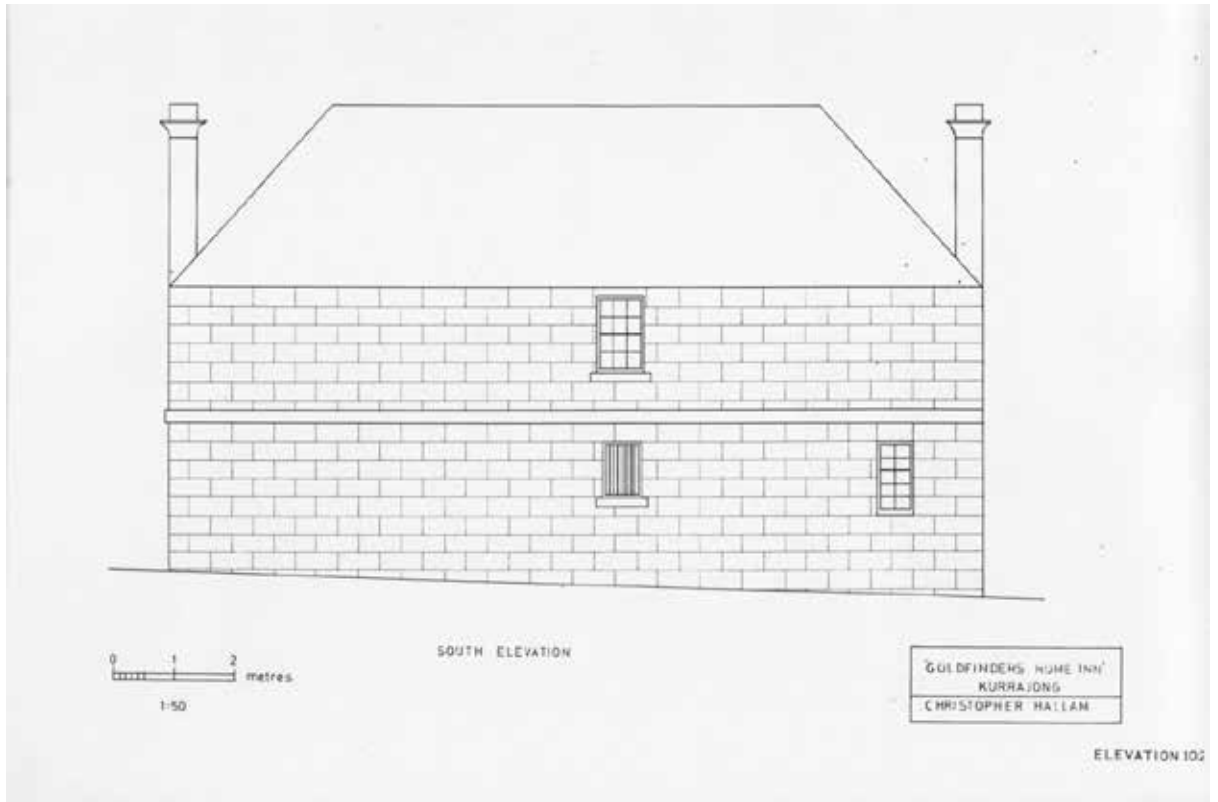
Figure 56 – South Elevation

On the southern wall, the ground floor kitchen window G has been enlarged, with a new window installed. As shown on Figure 56, the original window was narrower. This window is also seen in Figure 63. Also, on this wall there is the central barred window. In 1975 this solely consisted of the bars, without any glass panels. A new single window panel was installed, hinging in.

On the southern side first floor level, the verandah was removed. This verandah was not part of the original construction. It can be seen in Figures 59 and 63. In 1975/76 it was a bit unstable and being south-facing, was less usable. Figure 56 shows a window on the first floor on this wall, which is how it would have been built. Figure 54 correctly labels this “window” as a door, which would have been installed at the time the verandah was constructed at the first-floor level. Door M now in place was made from a standard cedar panelled door but with glazing bars replacing the top panels.

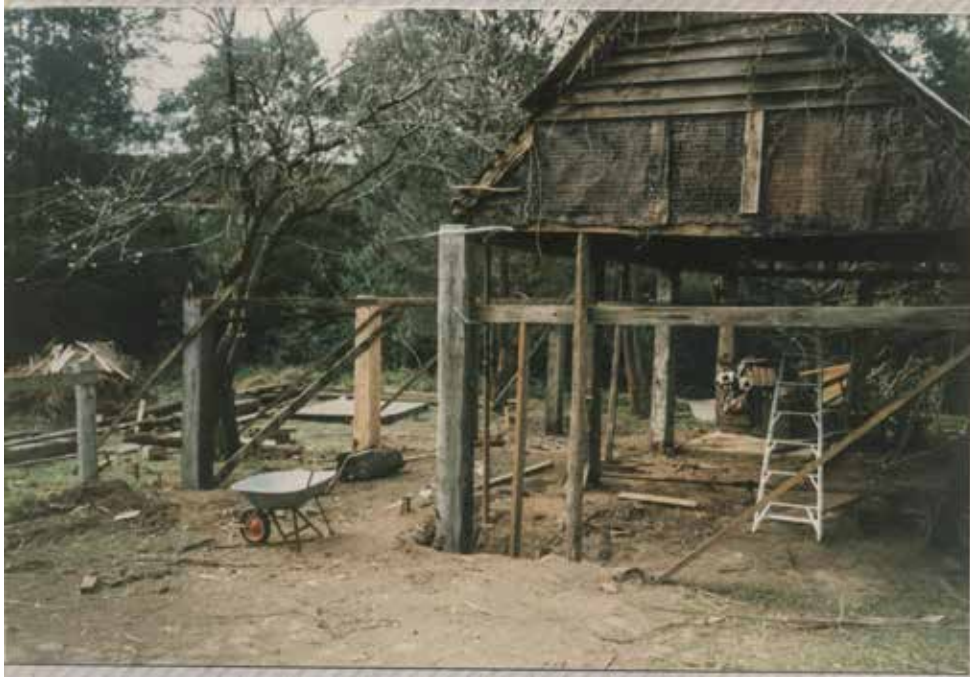
Figure 73 – Barn reconstruction in 1987

The reconstruction of the barn was undertaken in 1987. Timber posts were pulled straight with a tractor and new posts inserted as required. This can be seen in Figure 73. The original roof and gable end sections remained in place while work proceeded beneath them. The original shingle roofing is still in place under the iron on the main roof section. These works provided a reconstructed main bay plus skillion bay. As well as the original shingle roof, some of the early hardware such as door hinges remain in the structure. The design of these hinges, the forged iron bolts and the timber-peg construction confirm the very early dating of this barn. Figures 75-84 show these details.

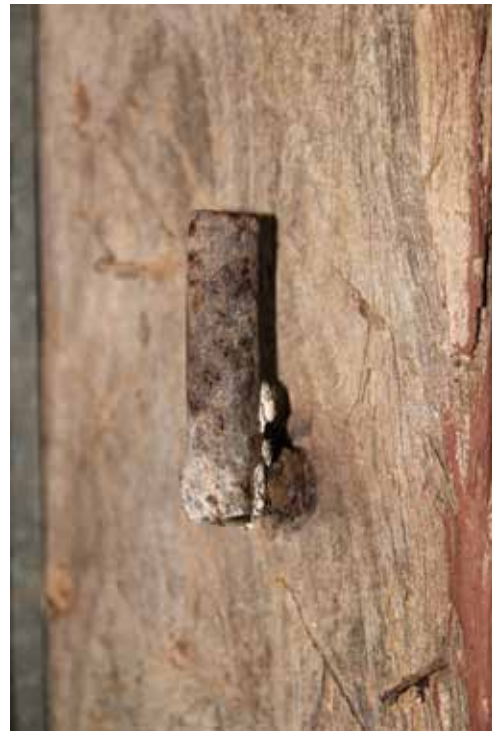
Figure 80 Gudgeon hinge post

Figure 79 shows an example of one of the bolts used in constructing this barn, with a square section iron bar, with a screw thread turned on one end. The bolt head is missing. Figure 80 shows another door post hinge. What is interesting is that this is a different type of construction to that shown in Figure 77, with a round section bar hammered into the post of the barn, without a screw at the other end.

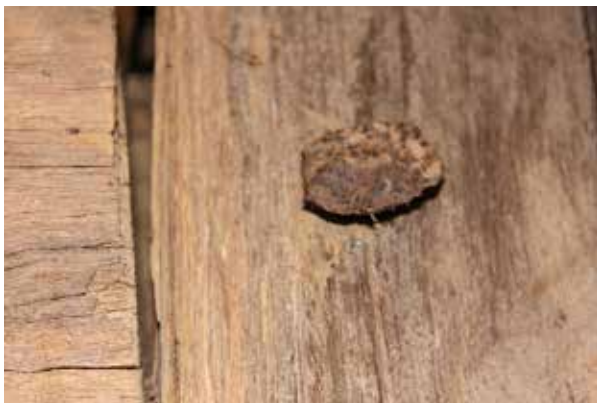
Figure 83 Head of nail or spike

Figure 83 shows the head of a long nail/spike hammered in to join the post with a horizontal beam. From looking at the joint, this nail was between 180 mm and 220 mm in length. A similar nail can be seen in the next post, again less than 220 mm in length. Similar nails/spikes are seen in Figure 114.
